Fixing Failures – Case Study 3

School ceiling collapse – West Midlands 2007

An article for the
Construction Fixings Association

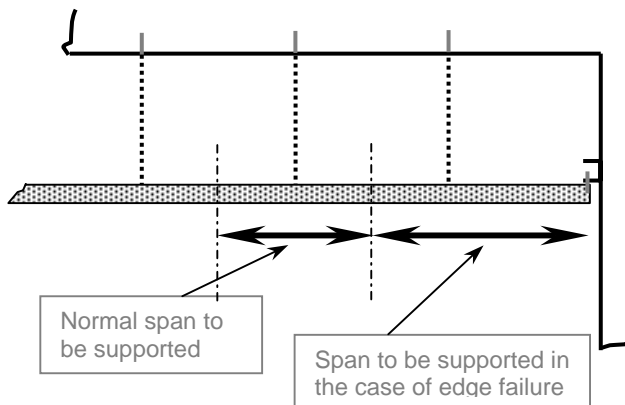
However, examination of the damage caused to the side walls suggested that there is every possibility that the collapse started at one edge and spread from there across the ceiling. Examination of the channel sections attached to the walls showed that in some cases the self tapping screws had passed through the very edge of the channel. Had these fixings failed then the first line of suspension hangers would have been required to support a far higher load than in normal service due to the distance from the wall being greater than half the normal span.

The normal span to be supported by each fixing is equal to the spacing between them but in the case of an edge failure the first line of fixings has to support any additional span if the line of fixings is further than half the normal spacing from the edge. Even the fact that any unsupported load at the edge of the structure will be at a significant bending moment means that additional fixings should be installed at the perimeter and in the first line of hangers.

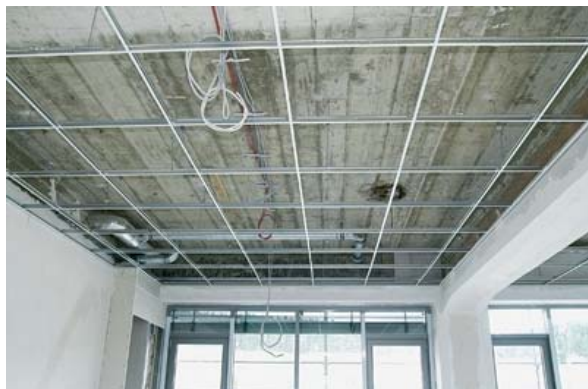
Ceiling with first line of hangers set at less than half the normal span from each edge

With respect to the design this should be done so as to ensure true redundancy by specifying additional fixings around the perimeter. One part of ETAG 001 – Part 6[1] is specifically designed for anchors to be used in this or other “Multiple use” applications such as pipework and is geared such that complicated calculations about redundancy can be avoided.
